# Horizon Heights Condominiums

## Level 1 Reserve Study

<b>Type of Study</b>	<b>Full Study</b>
<b>Date of Property Inspection</b>	<b>5/23/2024</b>
<b>Prepared By</b>	<b>Dale Gifford</b>
<b>Analysis Method</b>	<b>Cash Flow</b>
<b>Funding Goal</b>	<b>Full Funding</b>

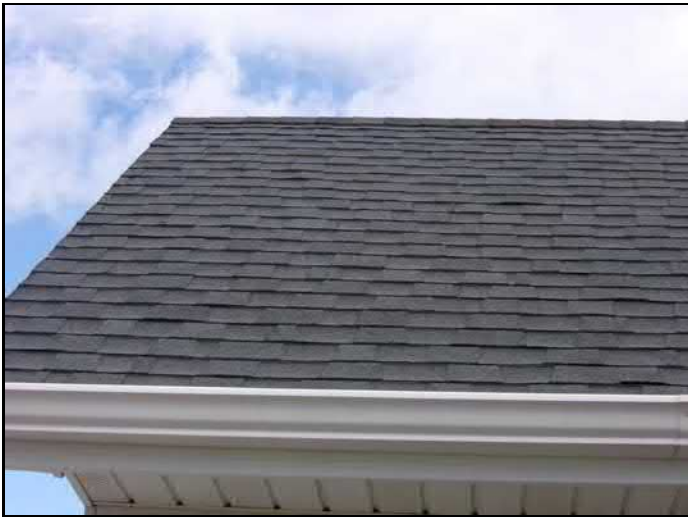
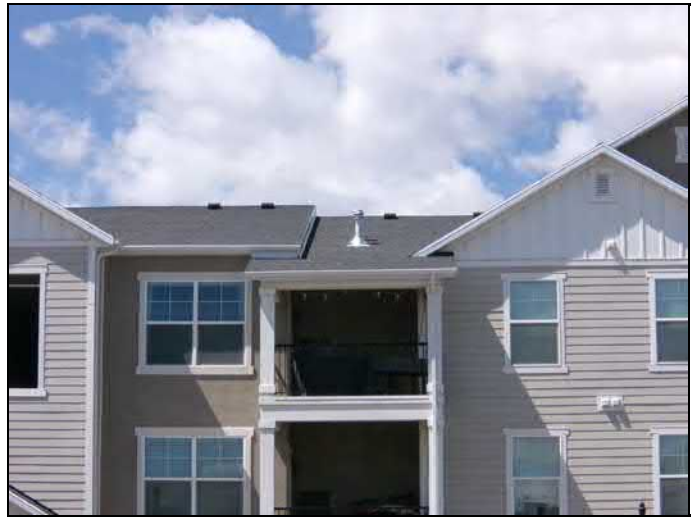
Comp #: 105    Roofs - Replace

The roofs appear to be in good condition. We recommend funding to replace this component approximately every 20 - 25 years. Remaining life based on current age.

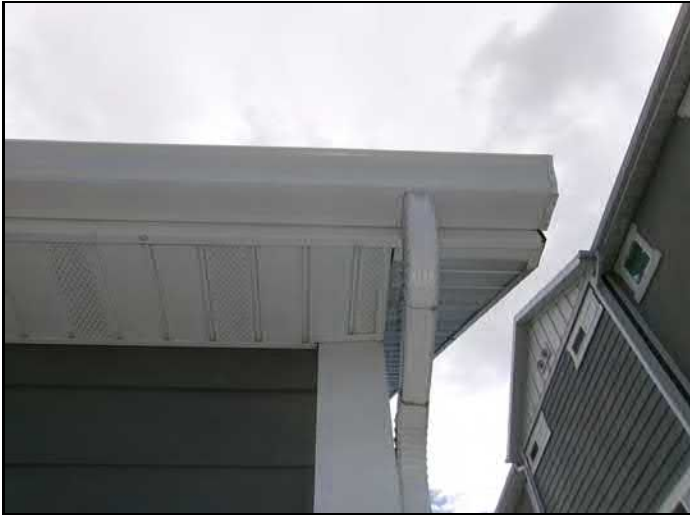
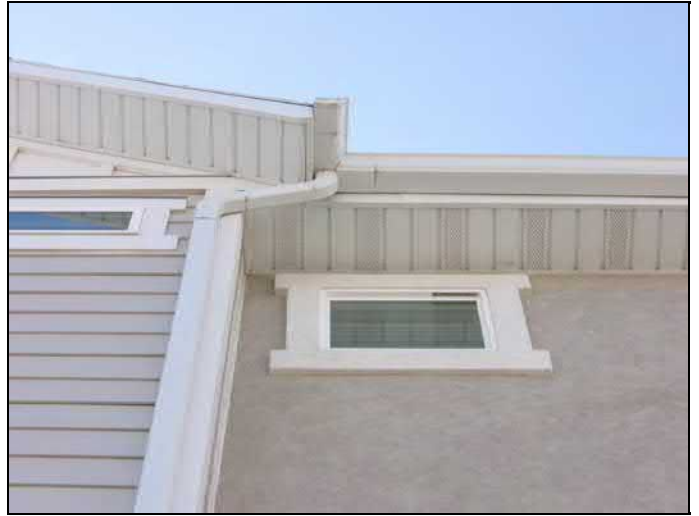
Comp #: 120 Rain Gutters/Downspouts - Replace

The rain gutters and downspouts are in good condition. We recommend funding to replace this component approximately every 25 - 30 years. Remaining life based on current age.

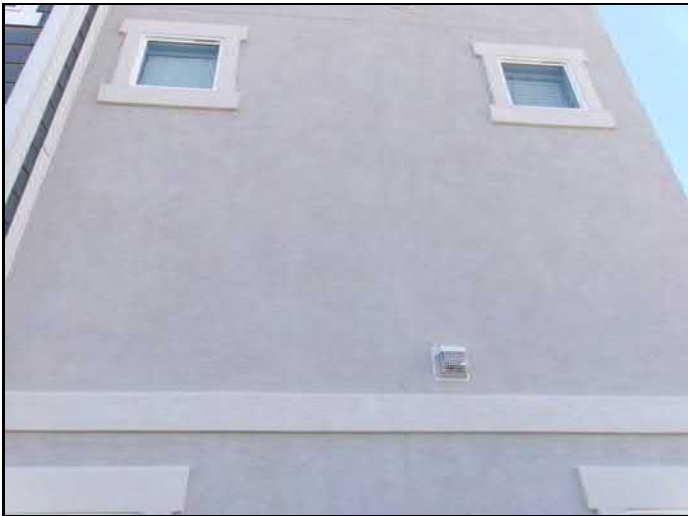
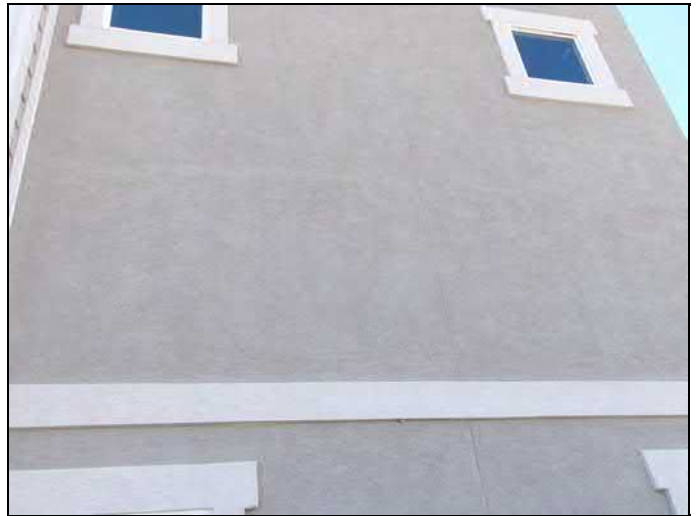
Comp #: 201 Stucco Surfaces - 2017 - Repair/Repaint

The stucco surfaces are in good condition. We recommend funding to repair/repaint this component approximately every 12 - 15 years. Remaining life based on current age.

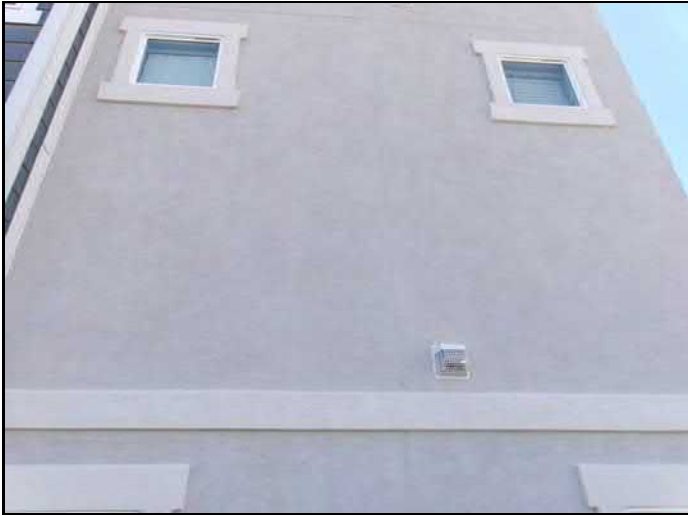
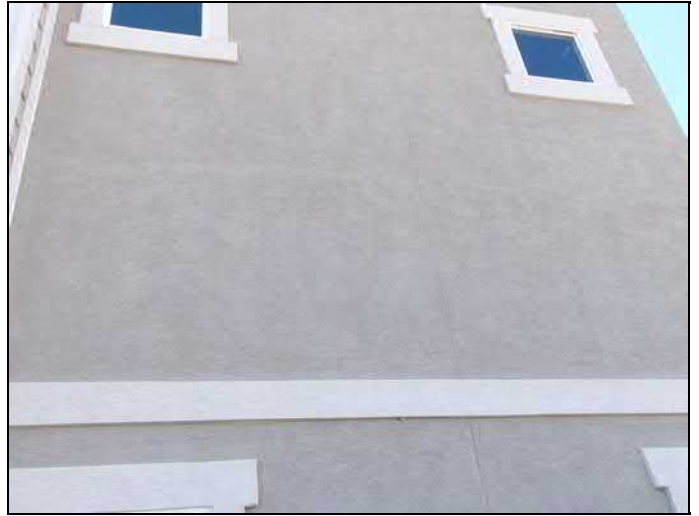
Comp #: 201 Stucco Surfaces - 2018 - Repair/Repaint

The stucco surfaces are in good condition. We recommend funding to repair/repaint this component approximately every 12 - 15 years. Remaining life based on current age.

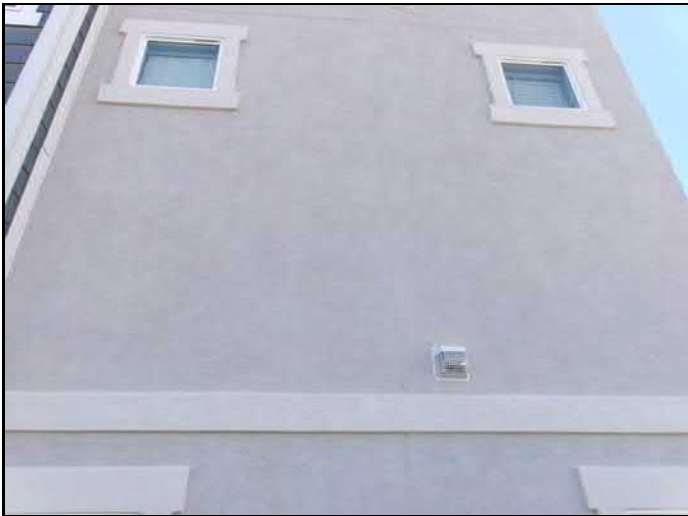
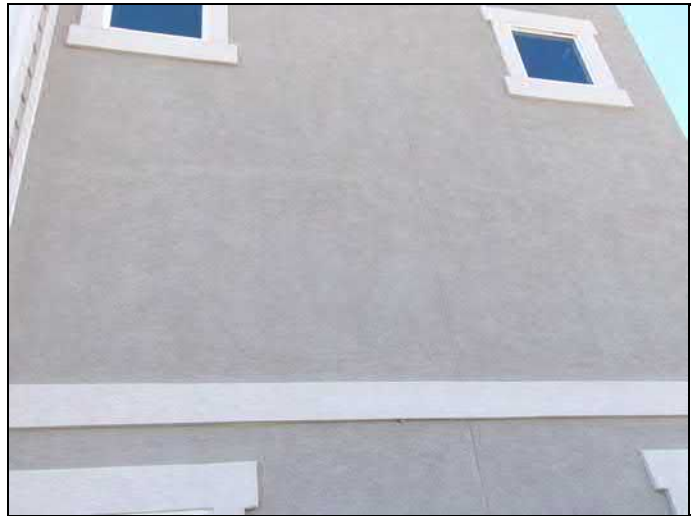
Comp #: 201 Stucco Surfaces - 2019 - Repair/Repaint

The stucco surfaces are in good condition. We recommend funding to repair/repaint this component approximately every 12 - 15 years. Remaining life based on current age.

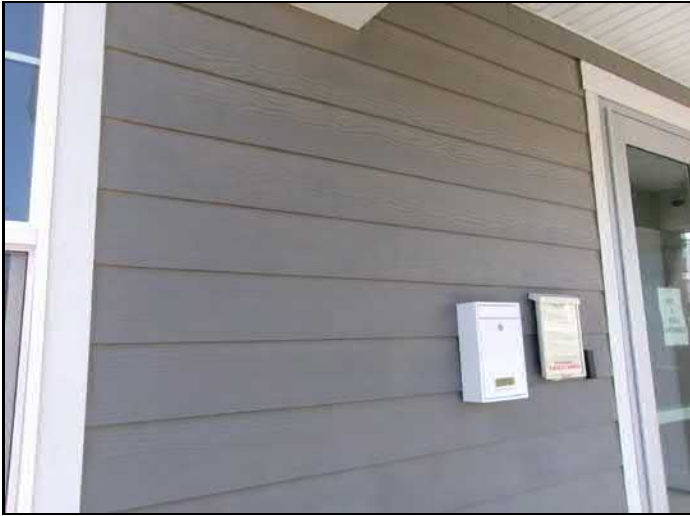
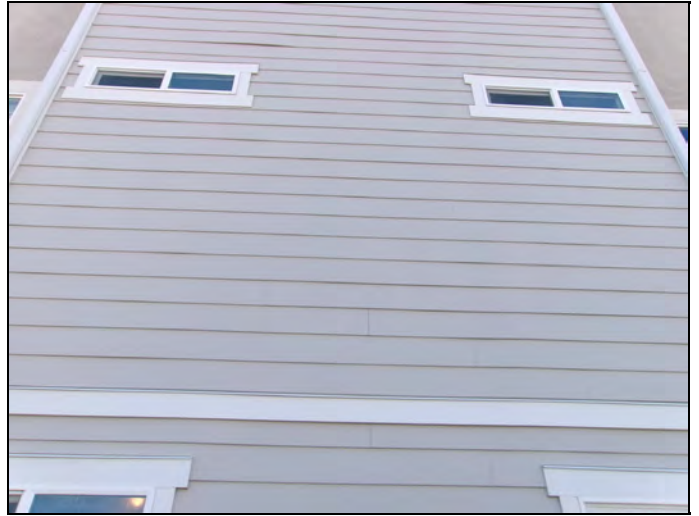
Comp #: 215 Siding - 2017 - Repair/Repaint

The siding painted surfaces are in fair condition. We recommend funding to repair/repaint this component approximately every 8 - 10 years. Remaining life is based on current age.

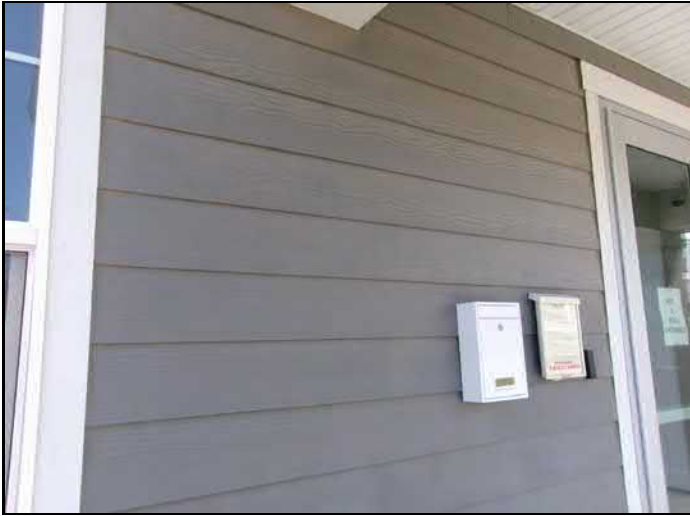
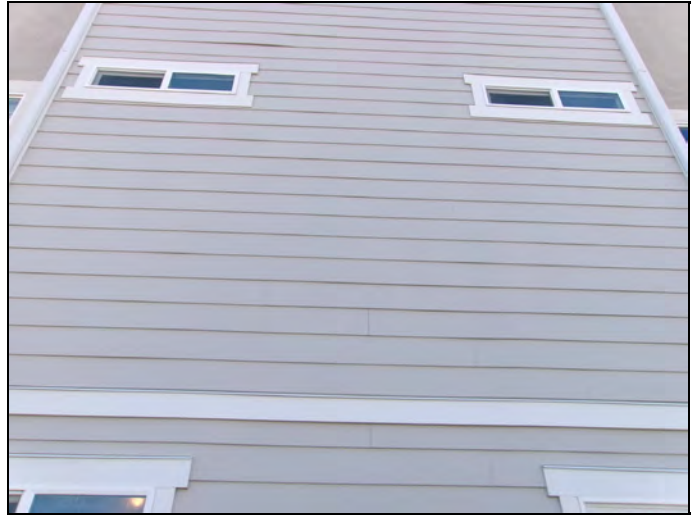
Comp #: 215 Siding - 2018 - Repair/Repaint

The siding painted surfaces are in fair condition. We recommend funding to repair/repaint this component approximately every 8 - 10 years. Remaining life is based on current age.

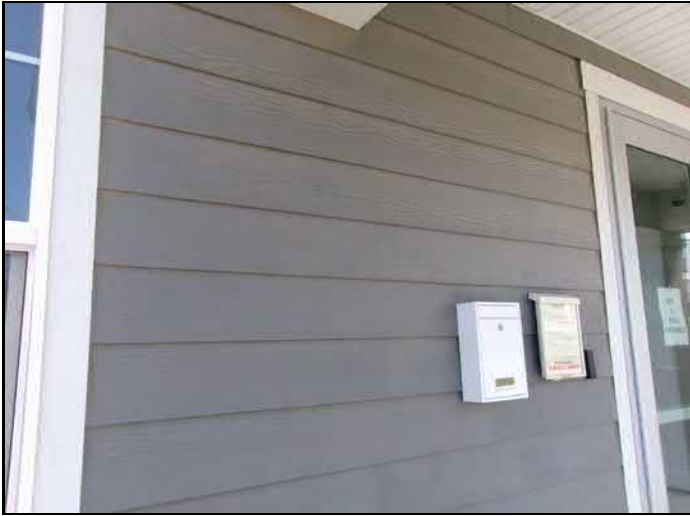
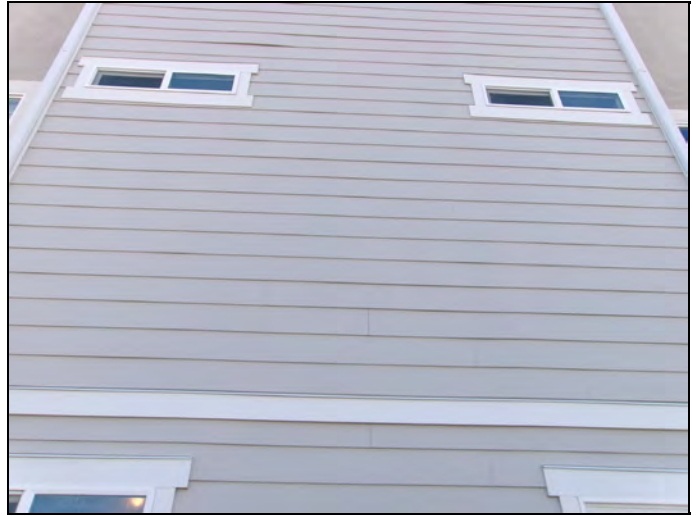
Comp #: 215 Siding - 2019 - Repair/Repaint

The siding painted surfaces are in fair condition. We recommend funding to repair/repaint this component approximately every 8 - 10 years. Remaining life is based on current age.

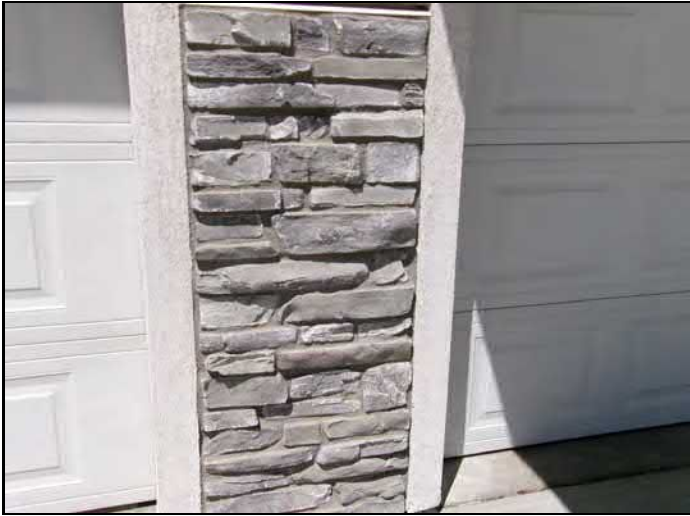
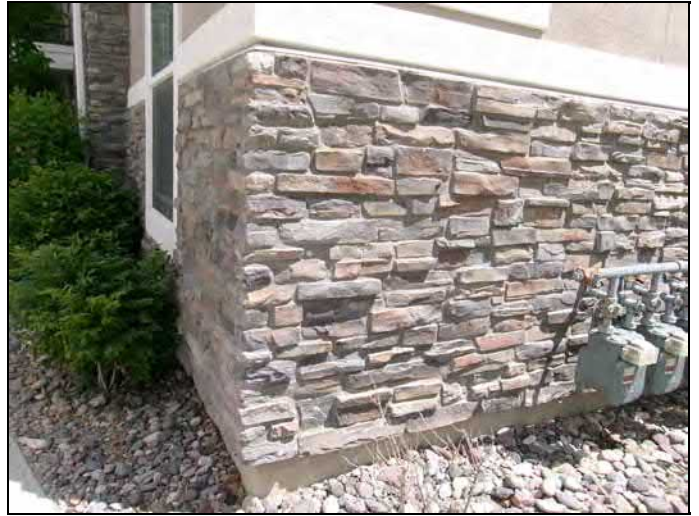
Comp #: 390 Faux Stone Siding - Repair

This component has an extended useful life. We recommend making repairs as necessary as an operating expense.

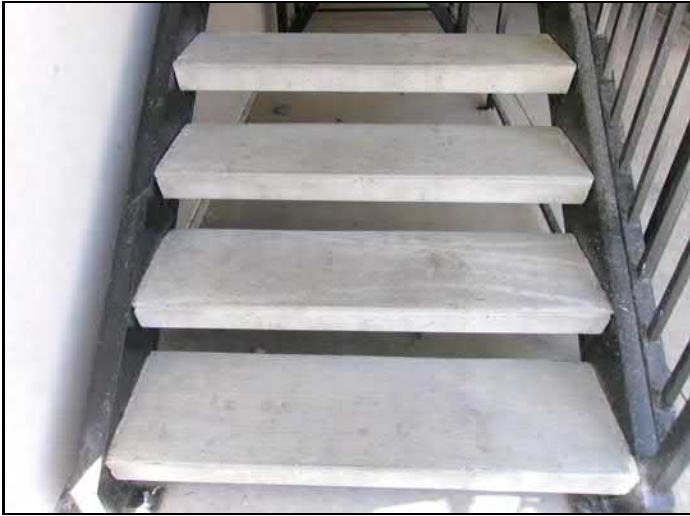
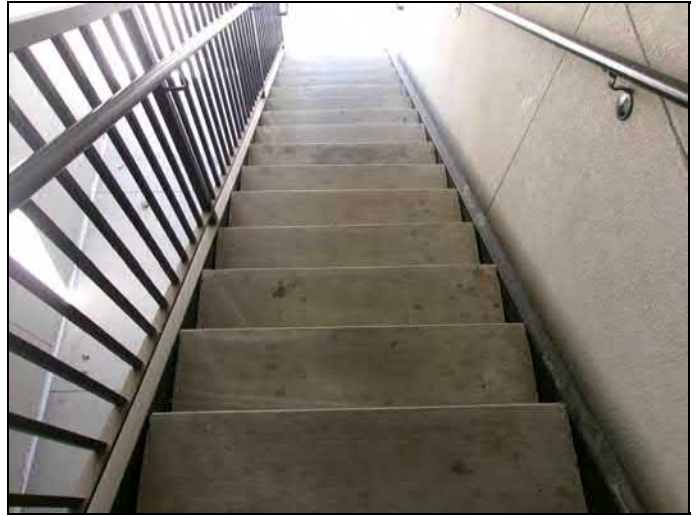
Comp #: 690 Concrete Stair Treads - Replace

The concrete stair treads are in good condition. We recommend funding to replace this component approximately every 30 - 40 years. Remaining life based on current age.
