# Horizon Heights Condominiums

## Level 1 Reserve Study

<b>Type of Study</b>	<b>Full Study</b>
<b>Date of Property Inspection</b>	<b>5/23/2024</b>
<b>Prepared By</b>	<b>Dale Gifford</b>
<b>Analysis Method</b>	<b>Cash Flow</b>
<b>Funding Goal</b>	<b>Full Funding</b>

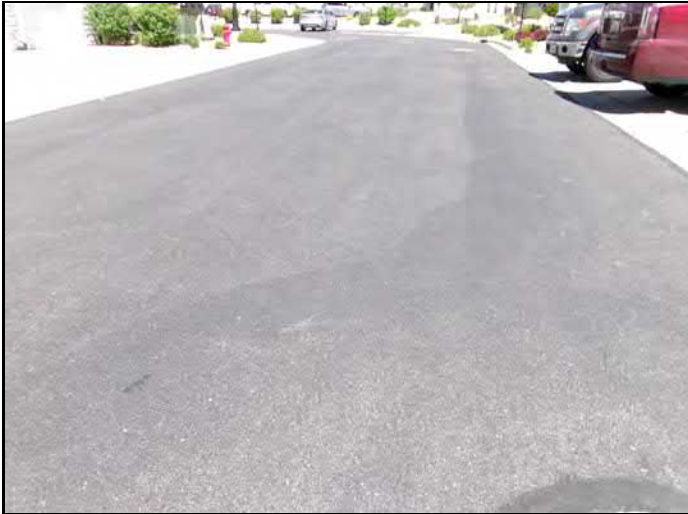
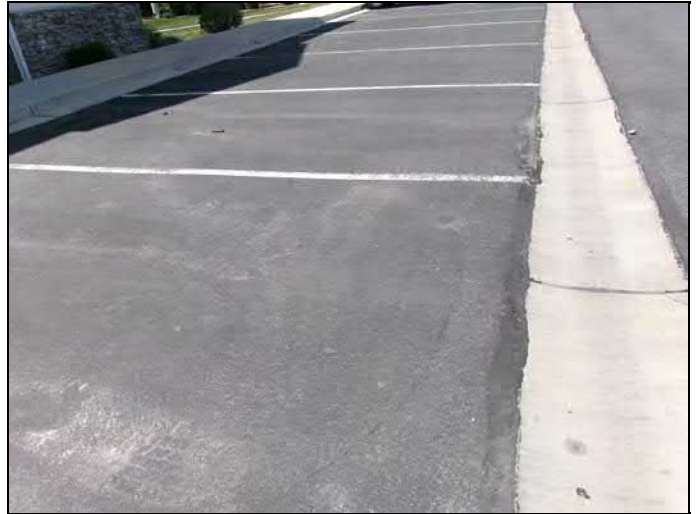
Comp #: 401 Asphalt - Major Rehab

The asphalt surfaces are in good condition. We recommend funding for a major rehab of this component approximately every 25 - 30 years. Remaining life based on current age.

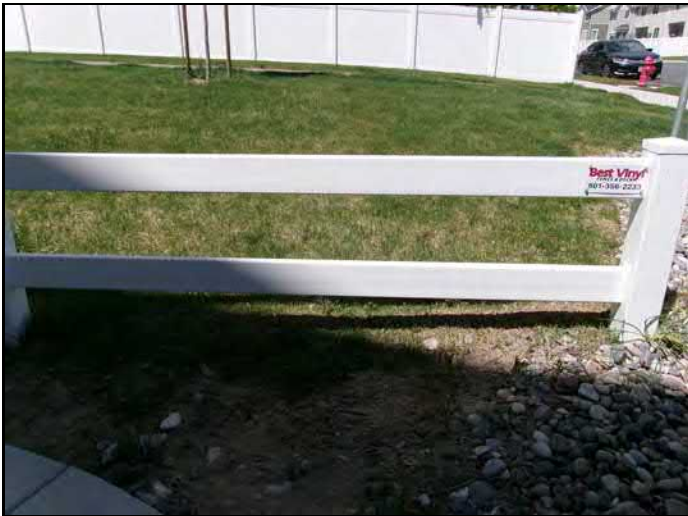
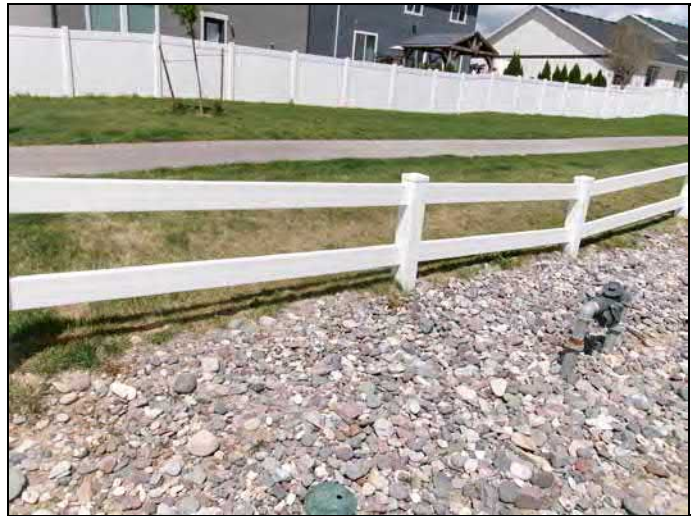
Comp #: 1008 Vinyl Fencing - Replace

The vinyl fencing is in good condition. We recommend funding to replace this component approximately every 25 - 30 years. Remaining life based on current age.

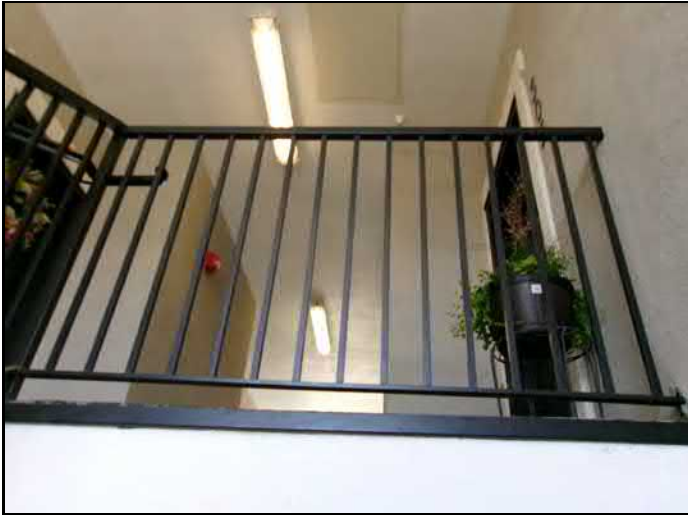
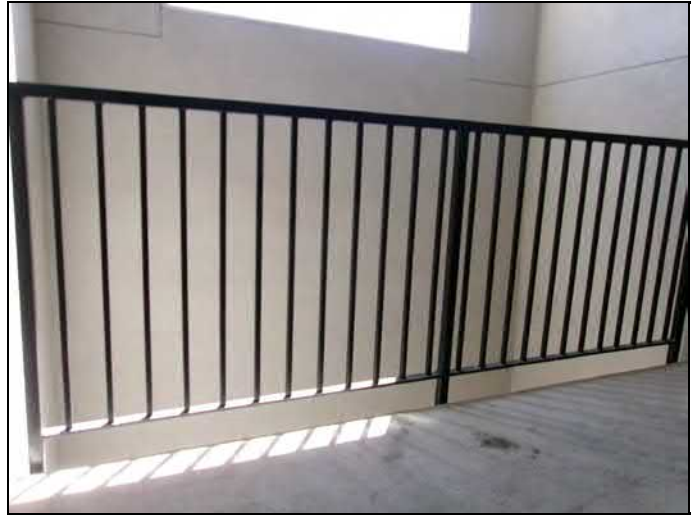
Comp #: 1090 Metal Railing - Replace

The painted metal railing surfaces are in fair condition. We recommend funding to paint this component approximately every 6 years. Remaining life based on current condition.

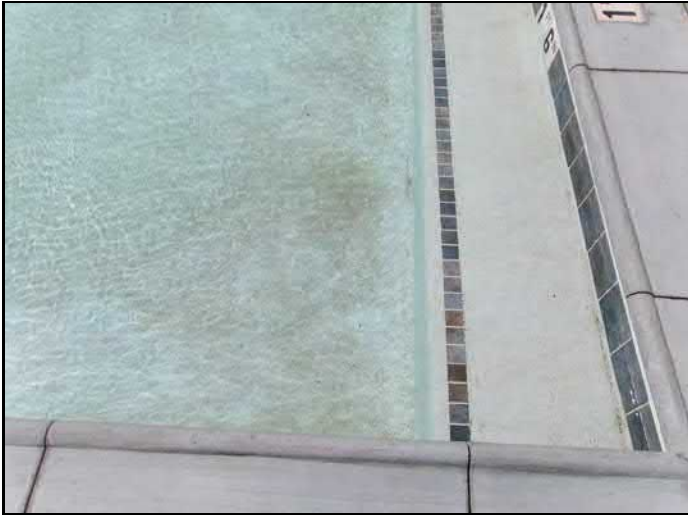
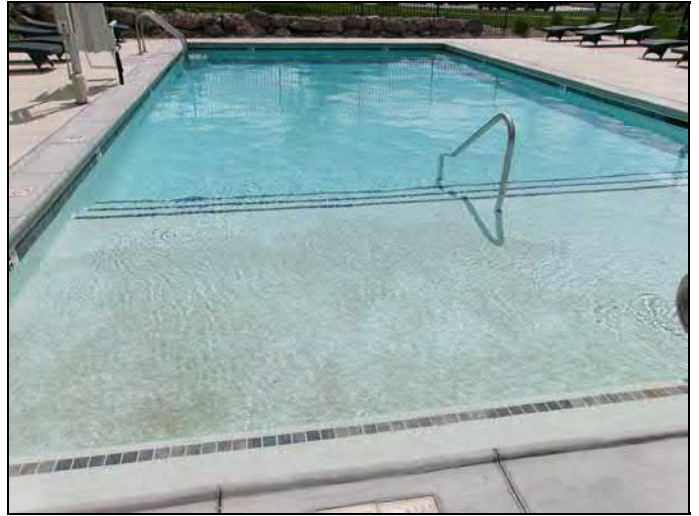
Comp #: 1101 Pool - Resurface

The pool surface is in fair condition. We recommend funding to resurface this component every 10 - 12 years. Remaining life based on current age.

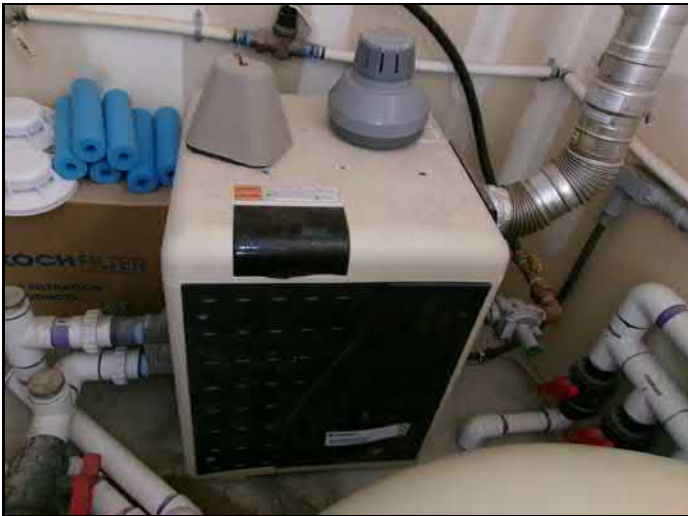
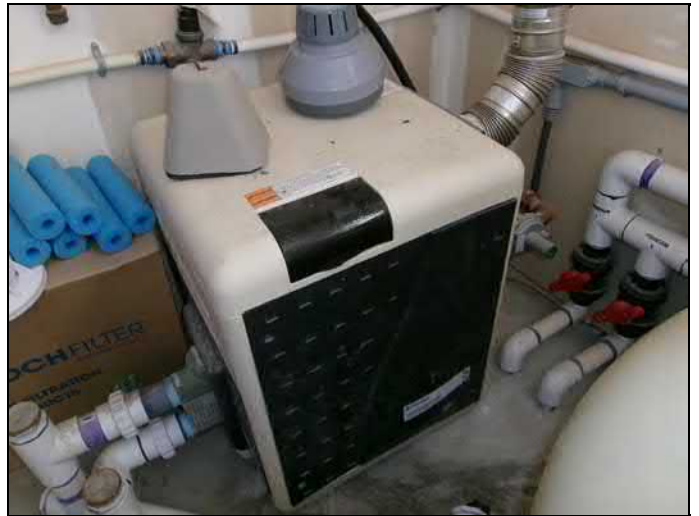
Comp #: 1104 Pool Heater - Replace

The pool heater is in working condition. We recommend funding to replace this component approximately every 12 years. Remaining life based on current age.

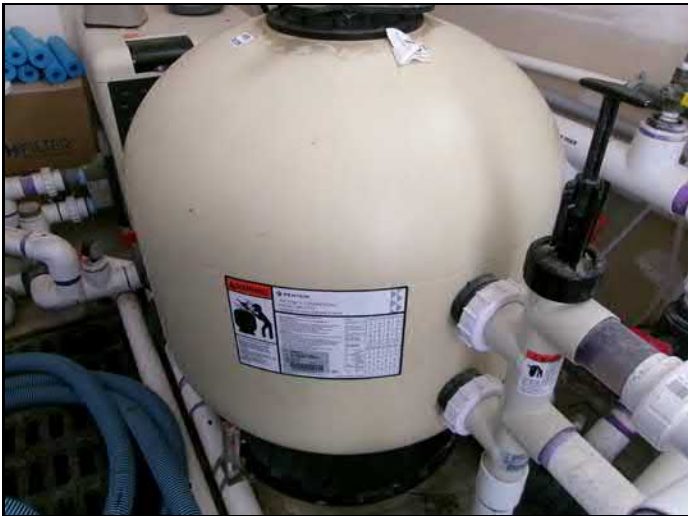
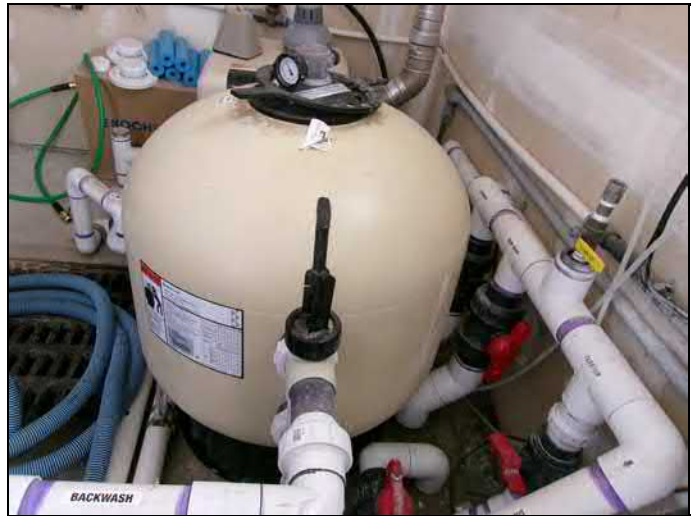
Comp #: 1107 Pool Filter - Replace

The pool filter is in working condition. We recommend funding to replace this component approximately every 12 - 15 years. Remaining life based on current age.

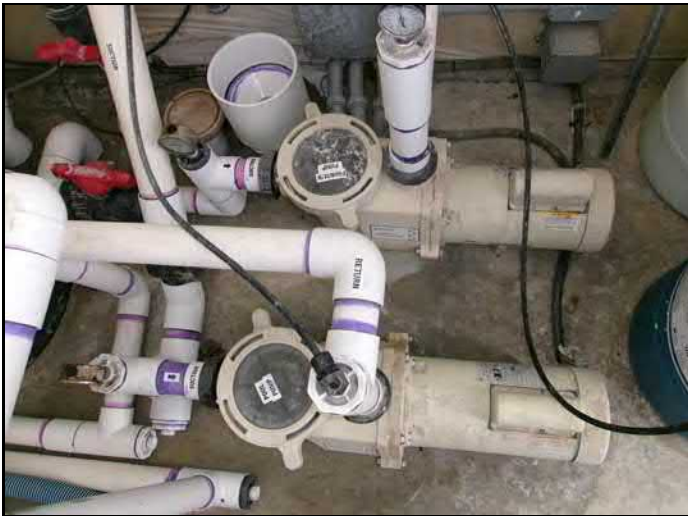
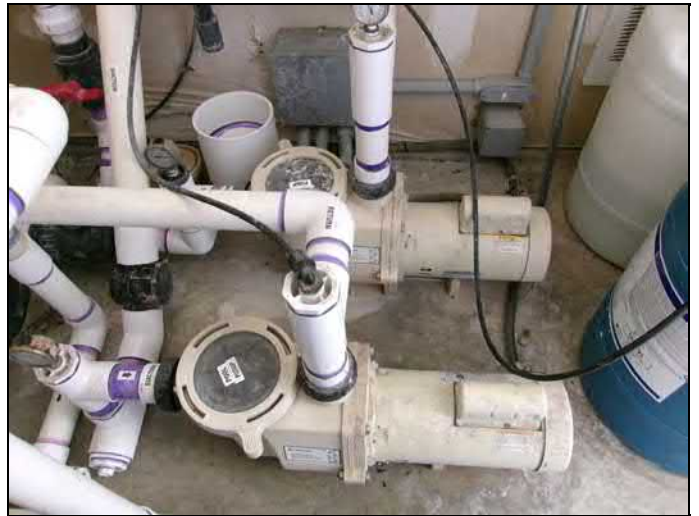
Comp #: 1110 Pool Pumps - Replace

The pool pumps are in working condition. We recommend funding to replace this component approximately every 8 - 10 years. Remaining life based on current age.

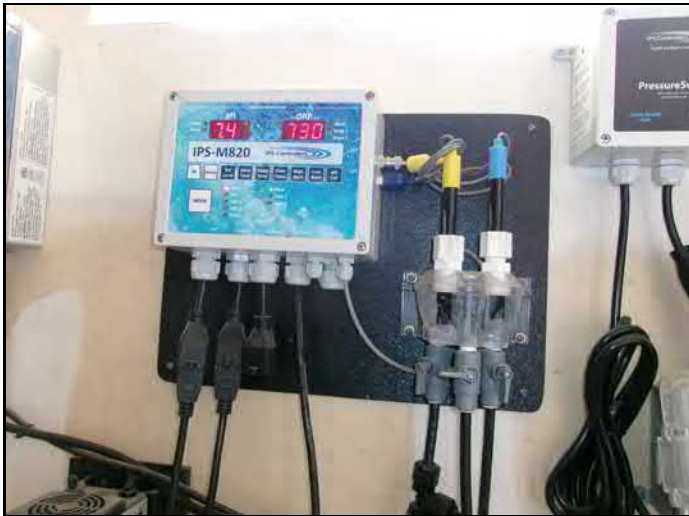
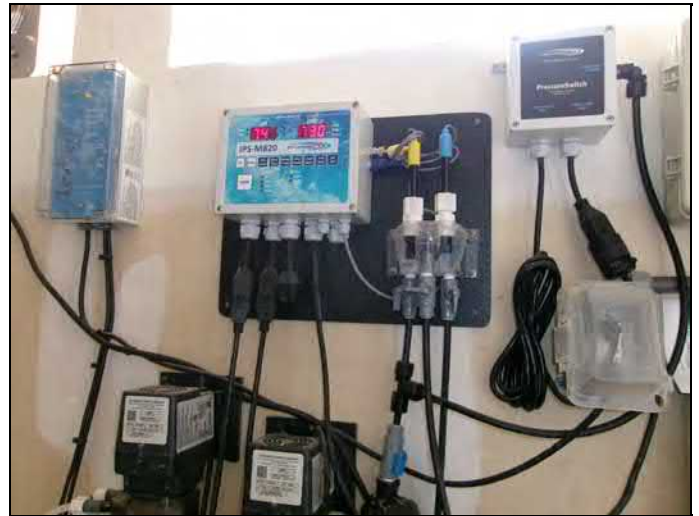
Comp #: 1111 Pool Chemical Controller System - Replace

The pool chemical controller system is in working condition. We recommend funding to replace this component approximately every 10 - 12 years. Remaining life based on current age.

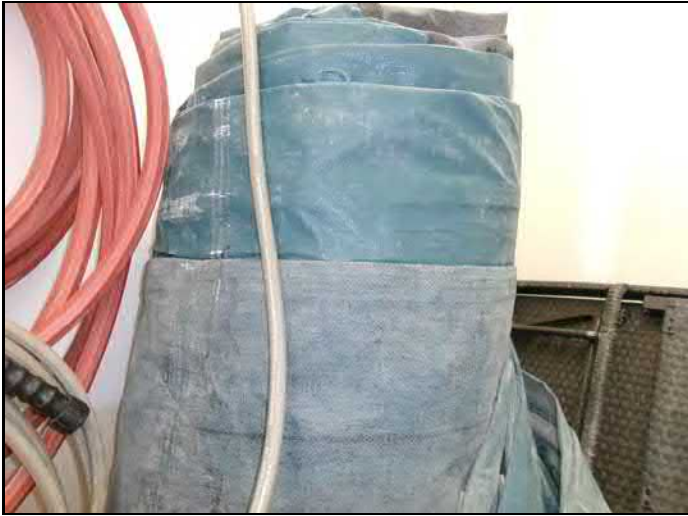
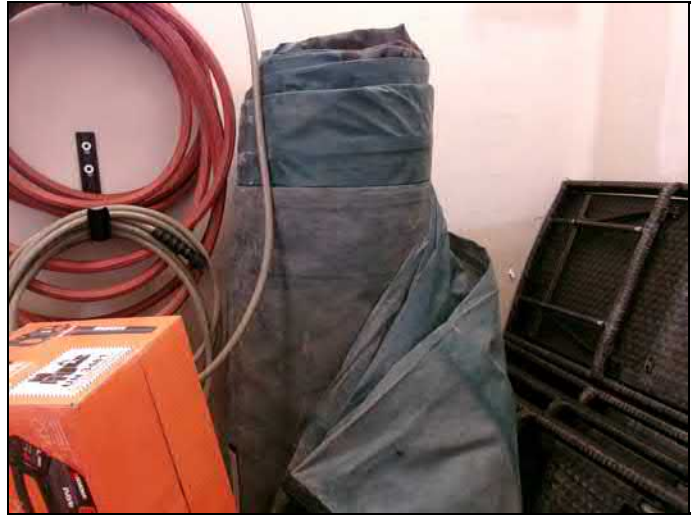
Comp #: 1112 Pool Cover - Replace

Unable to inspect this component at the time of the site visit. We recommend funding to replace this component approximately every 10 years. Remaining life based on current age.

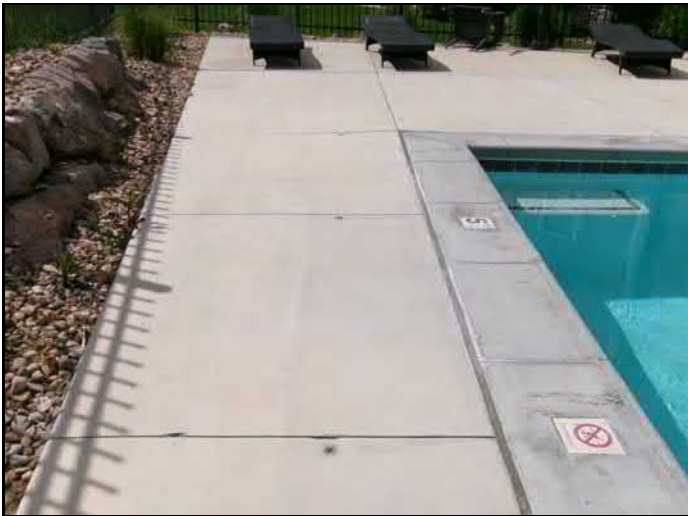
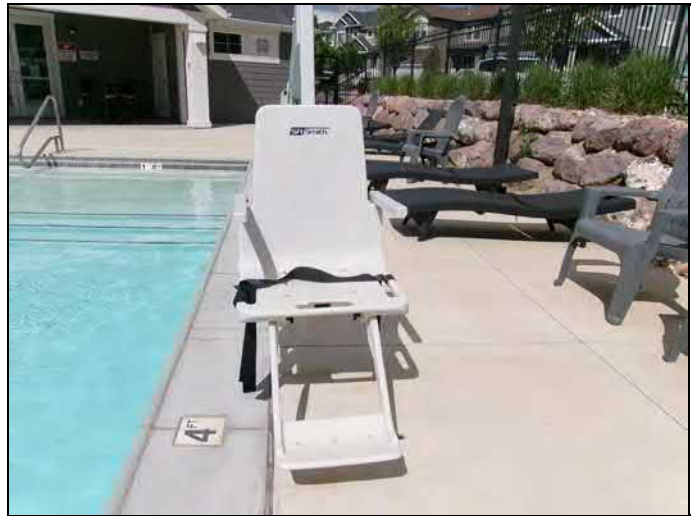
Comp #: 1116 Pool Deck - Replace

The pool deck is in good condition. We recommend funding to replace this component approximately every 40 - 50 years. Remaining life based on current age.

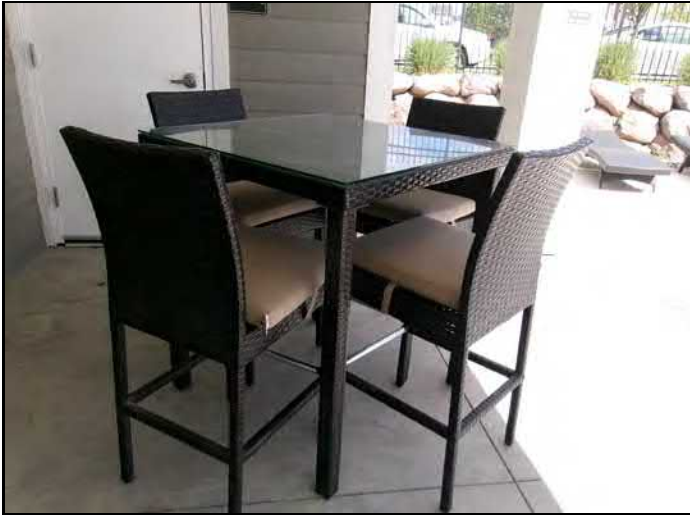
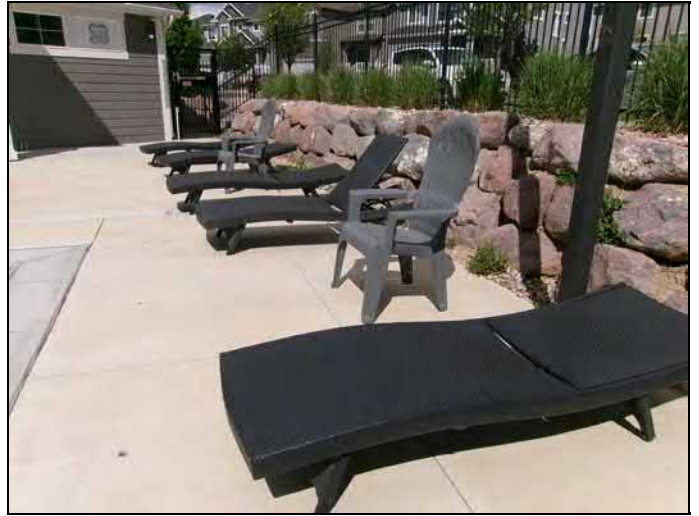
Comp #: 1121 Pool Furniture - Replace

The pool furniture is in good condition. We recommend funding an allowance to make replacements to this component approximately every 6 years. Remaining life based on current age.

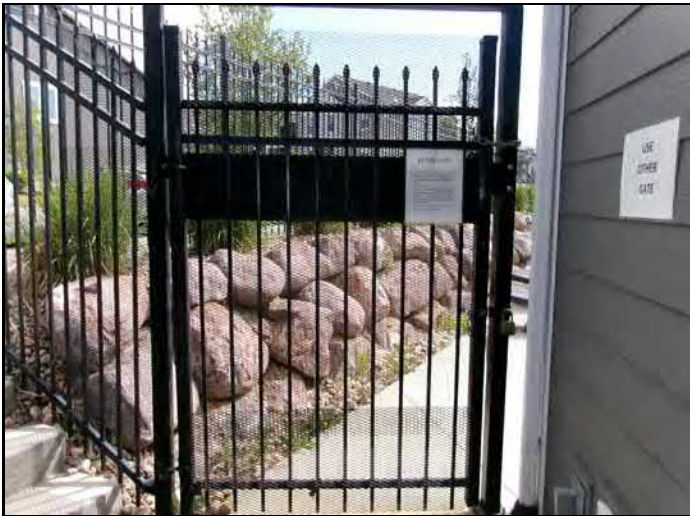
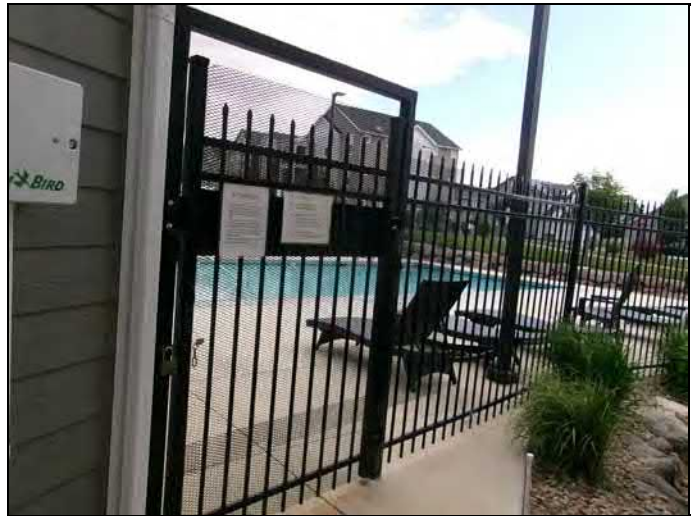
Comp #: 1190 Pool Gates - Replace

The pool gates are in good condition. We recommend funding to completely replace this component approximately every 25 - 30 years. Remaining life based on current age.

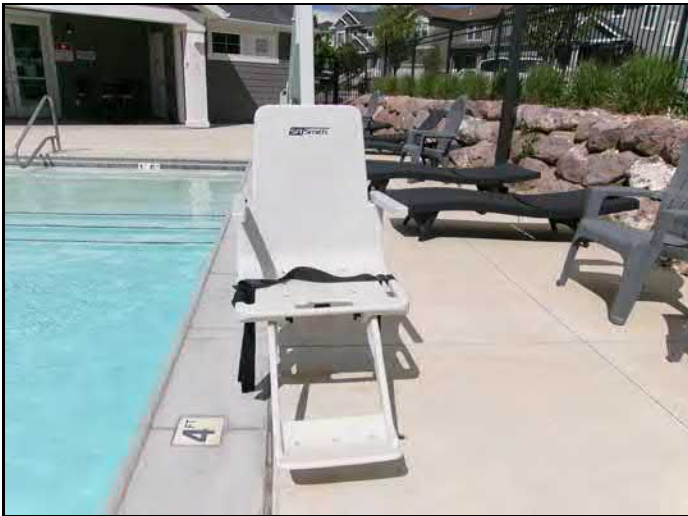
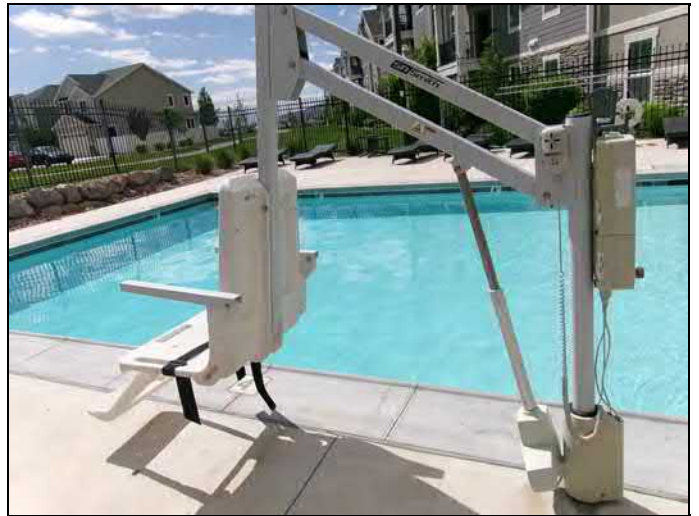
Comp #: 1190 Pool Lift - Replace

The pool lift appears to be in working condition. We recommend funding to replace this component approximately every 12 - 15 years. Remaining life based on current age.

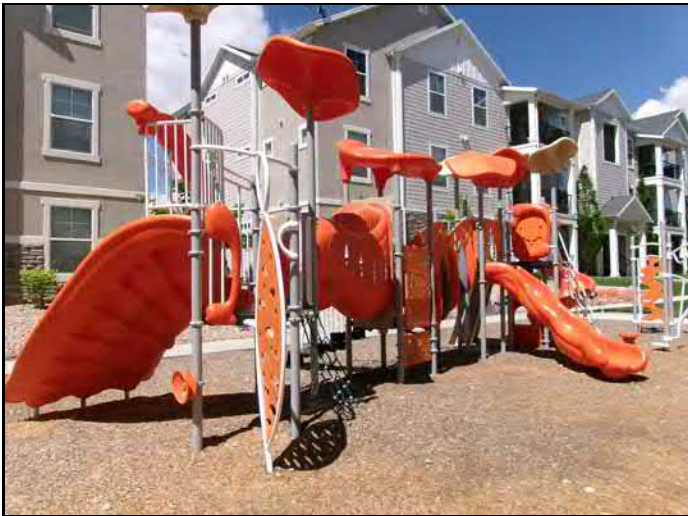
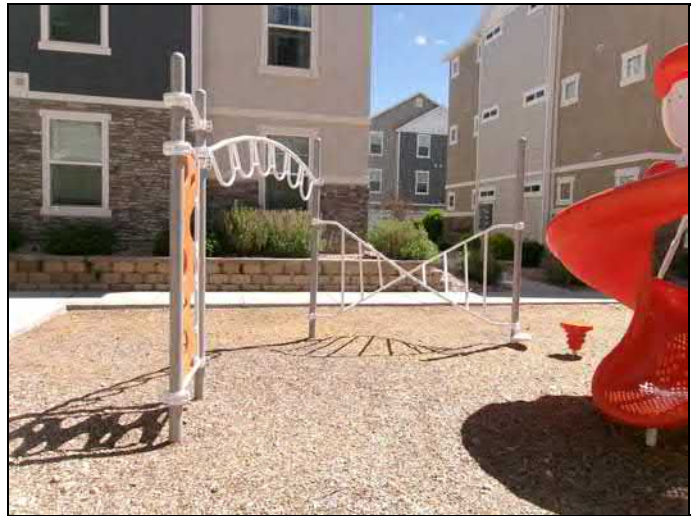
Comp #: 1301 Play Structures - Replace

The play structure is in good condition. We recommend funding to replace this component approximately every 20 - 25 years. Remaining life based on current age.

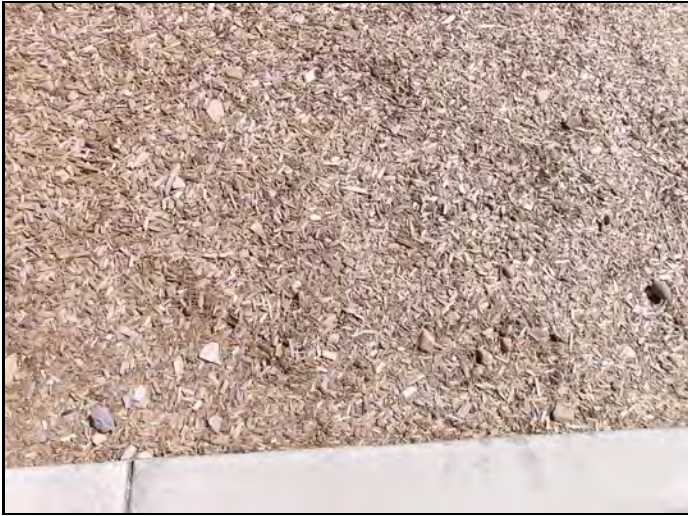
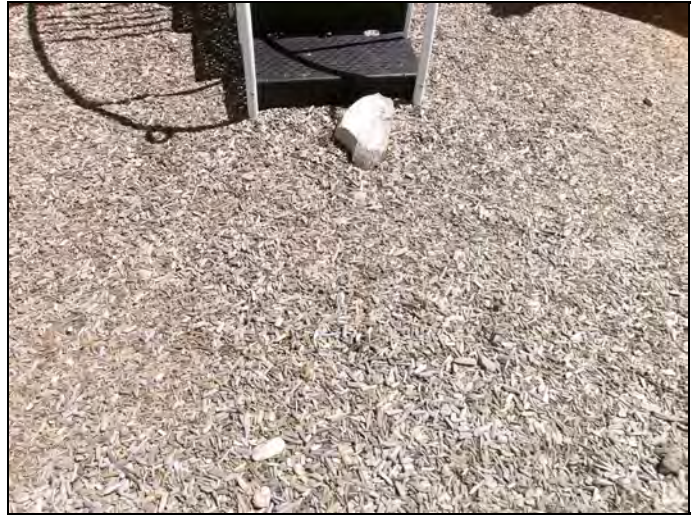
Comp #: 1303 Play Area Groundcover - Refill

The play area groundcover is in good condition. We recommend funding to refill this component approximately every 3 - 5 years. Remaining life is based on current age.

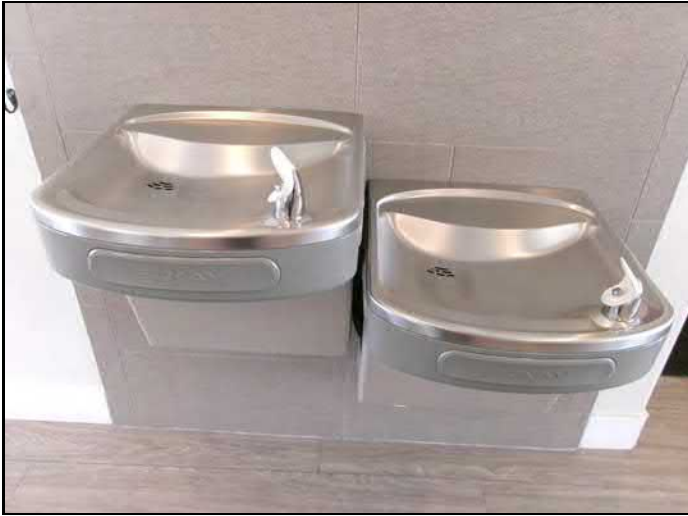
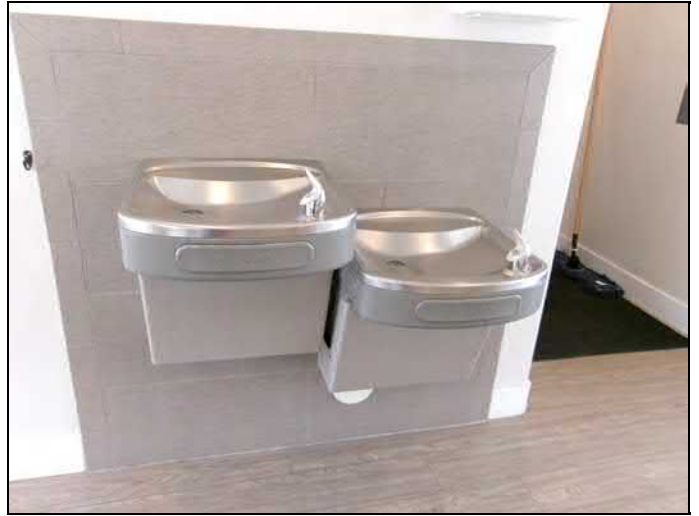
Comp #: 1304 Drinking Fountains - Replace

The drinking fountains are in working condition. We recommend funding to replace this component approximately every 10 - 15 years. Remaining life based on current age.

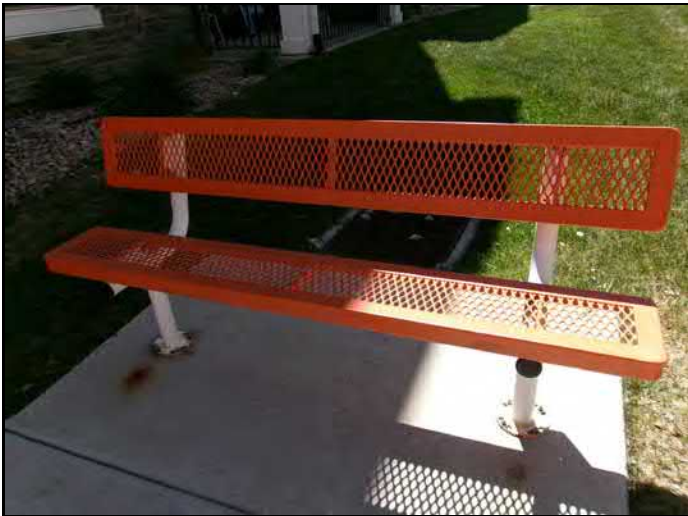
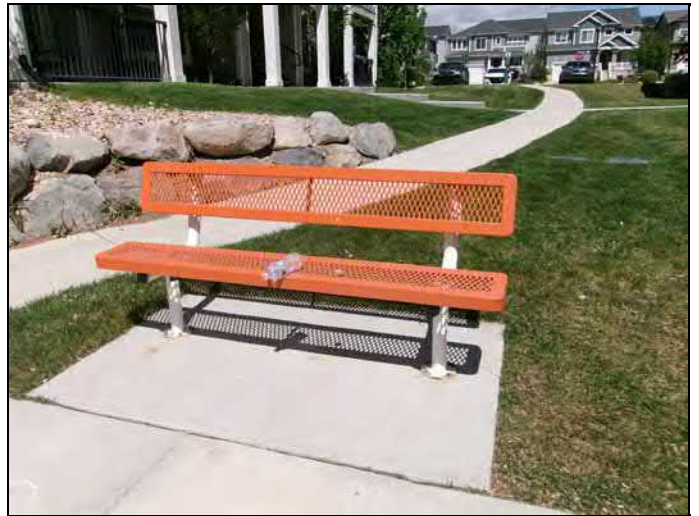
Comp #: 1307 Benches - Replace

The benches are in good condition. We recommend funding to replace this component approximately every 10 - 15 years. Remaining life based on current age.

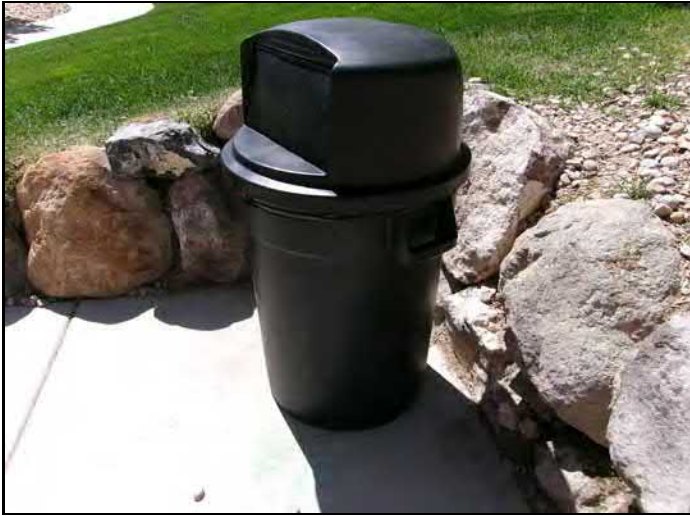
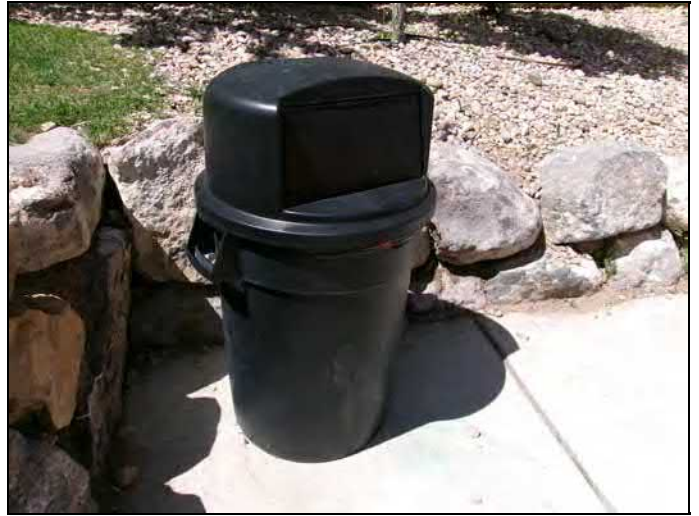
Comp #: 1308 Trash Receptacles - Replace

Due to the minimal cost of replacing this component, reserve funding is not appropriate. Replace as necessary as an operating expense.

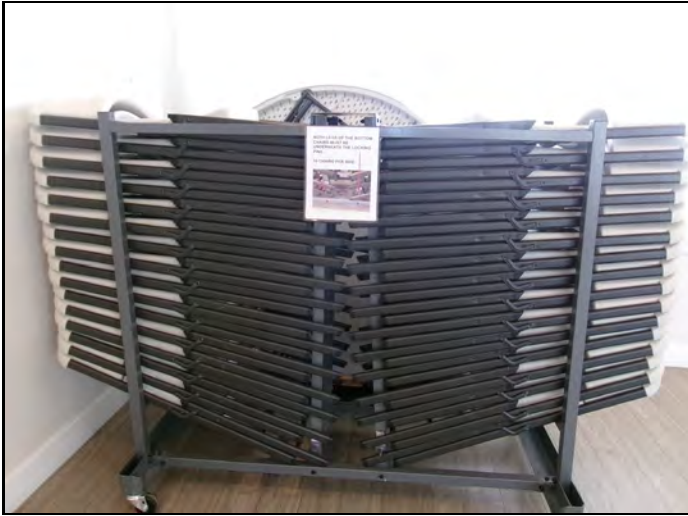
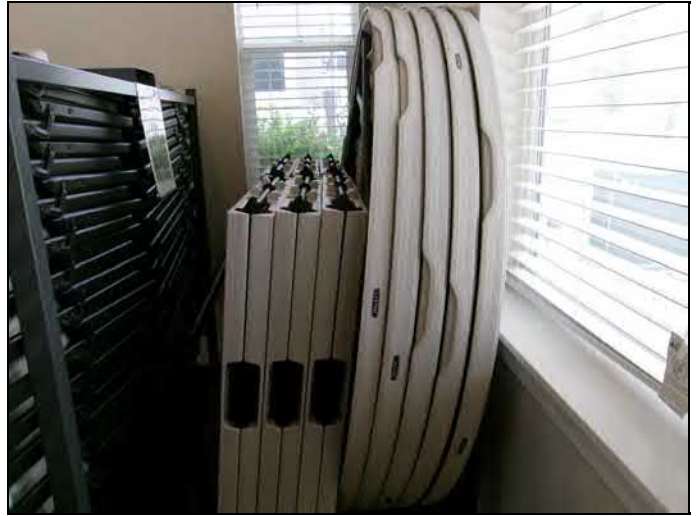
Comp #: 1405 Furniture - Replace

The furniture is in good condition. We recommend funding an allowance to make replacements approximately every 10 years. Remaining life based on current age.

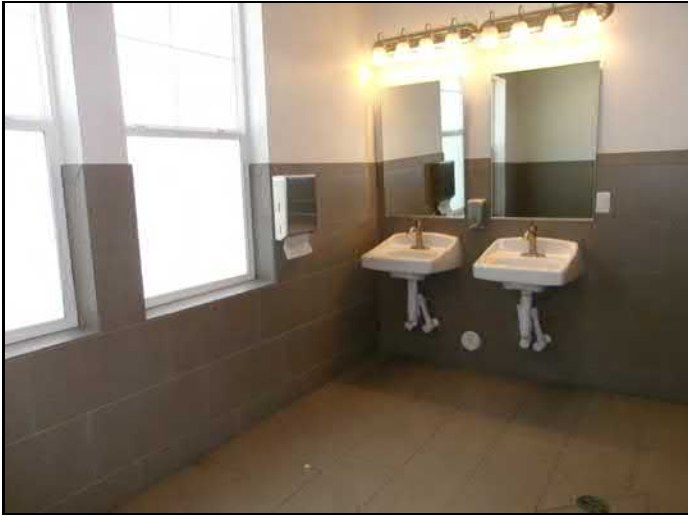
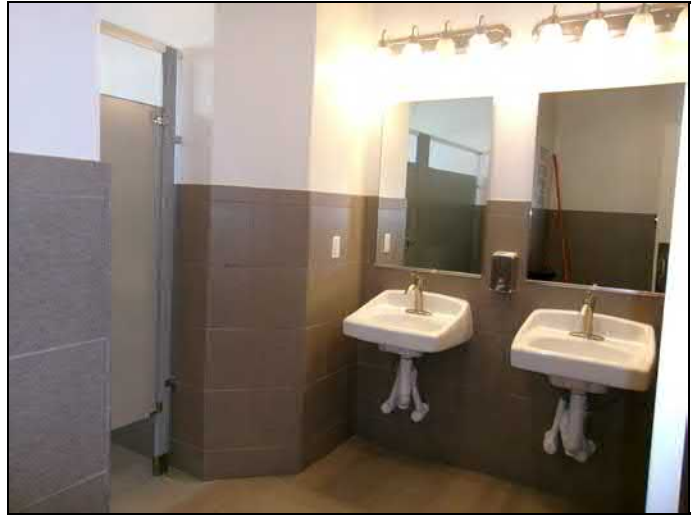
Comp #: 1413 Restrooms - Remodel

The restrooms are in good condition. We recommend funding to remodel this component approximately every 20 years. Remaining life based on current age.

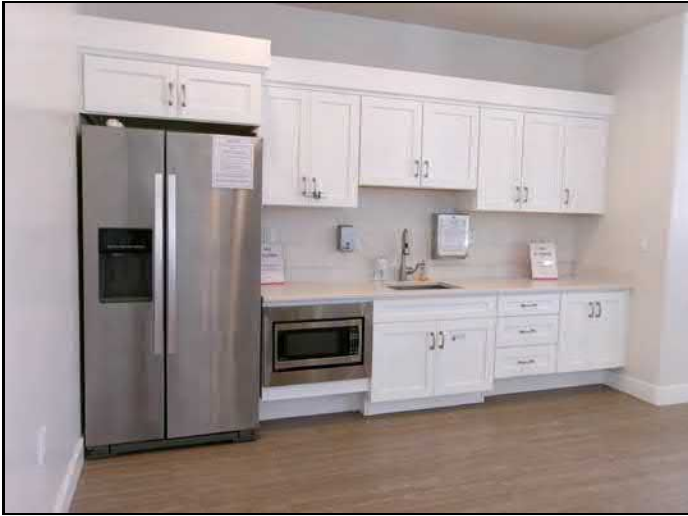
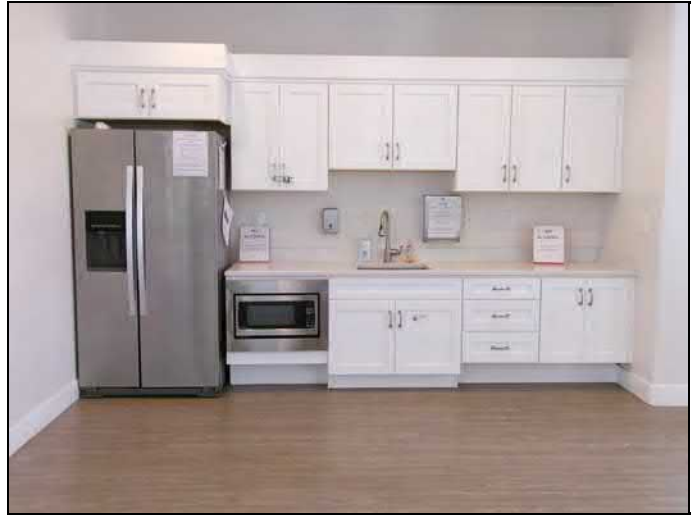
Comp #: 1417 Kitchen - Remodel

The kitchen is in good condition. We recommend funding to remodel this component approximately every 20 years. Remaining life based on current age.

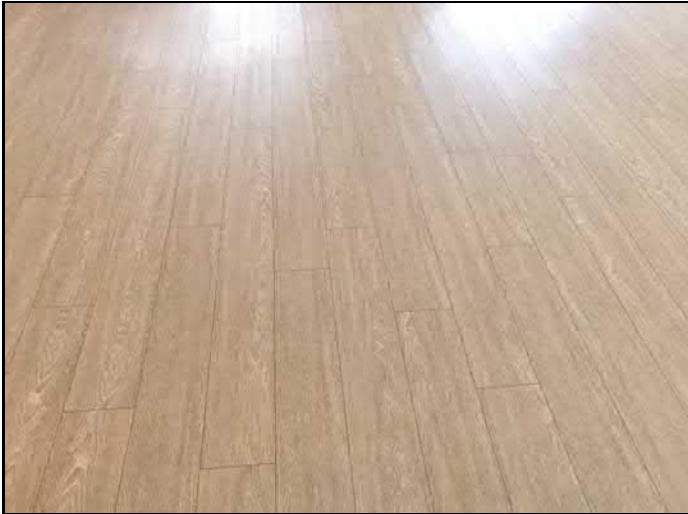
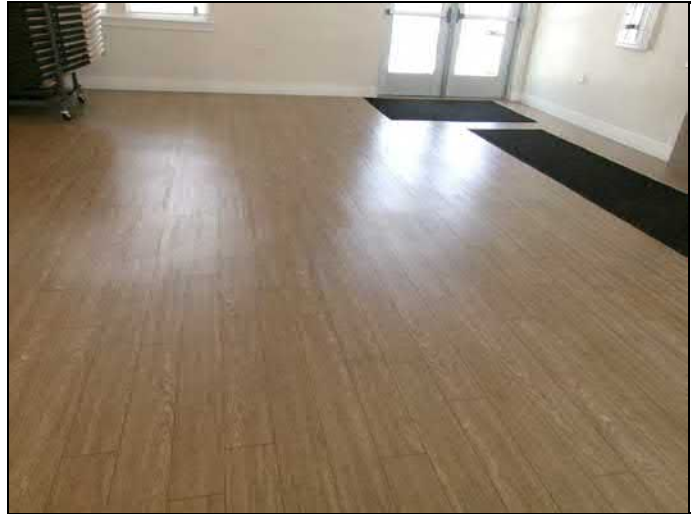
Comp #: 1502 Laminate Flooring - Replace

The laminate flooring is in good condition. We recommend funding to replace this component approximately every 20 - 25 years. Remaining life based on current age.

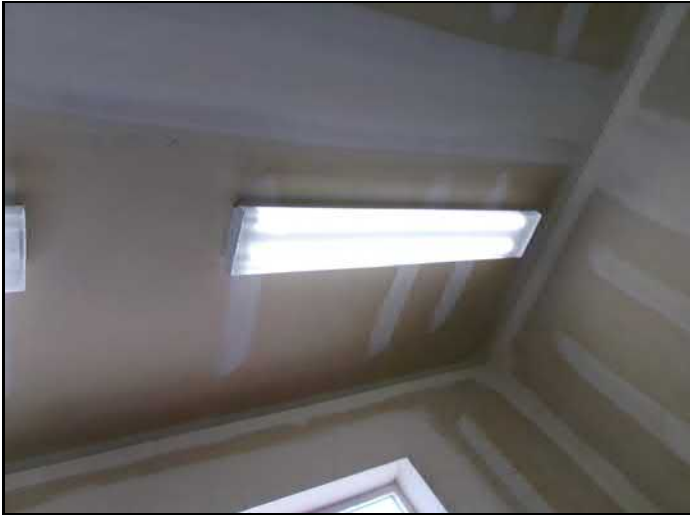
Comp #: 1601 Interior Light Fixtures - Replace

The interior light fixtures are in good condition. We recommend funding to replace this component approximately every 20 - 25 years. Remaining life based on current age.

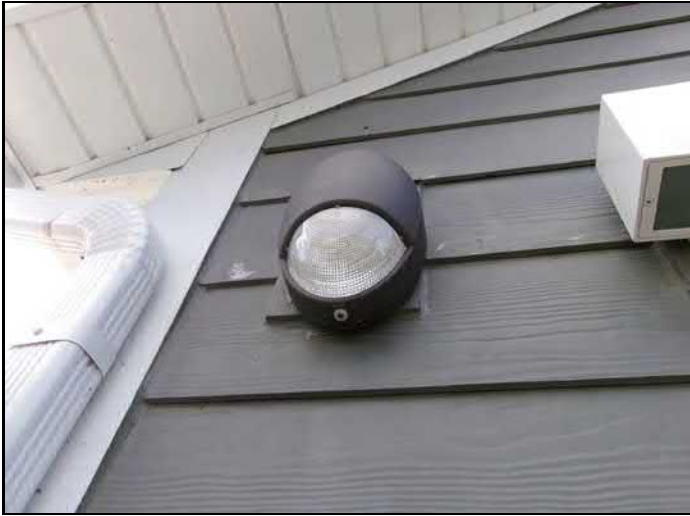
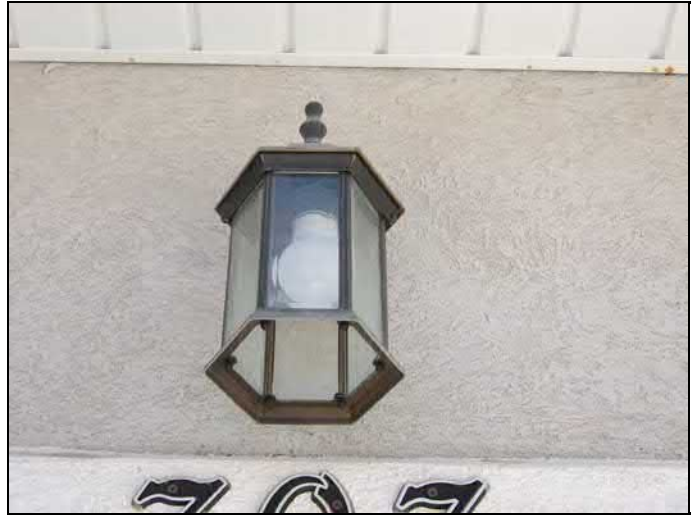
Comp #: 1602 Exterior Light Fixtures - Replace

The exterior light fixtures are in good condition. We recommend funding to replace this component approximately every 16 - 20 years. Remaining life based on current age.

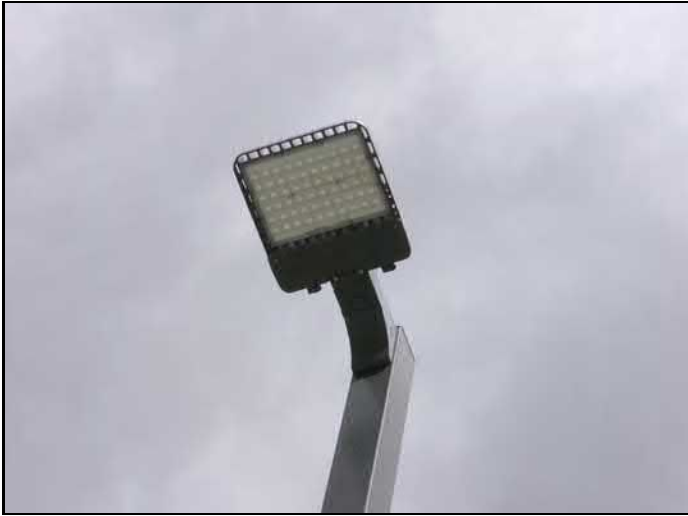
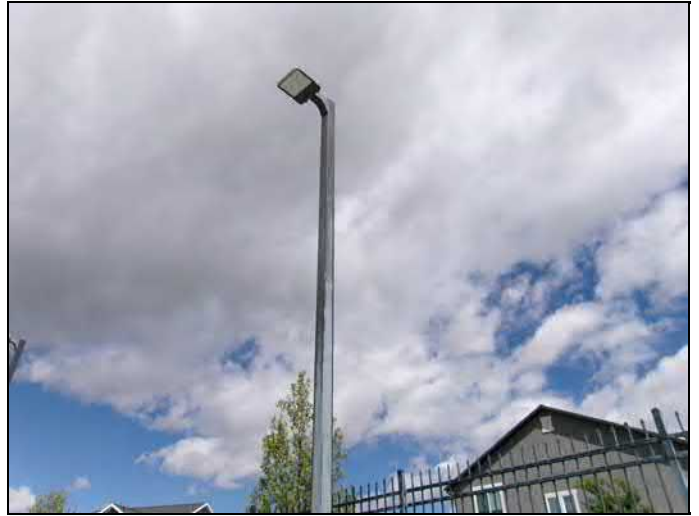
Comp #: 1606 Pool Light Fixtures - Replace

The pool light fixtures are in good condition. No expectation to replace the light poles. Paint poles as necessary as an operating expense. We recommend funding to replace this component approximately every 20 years. Remaining life based on current age.

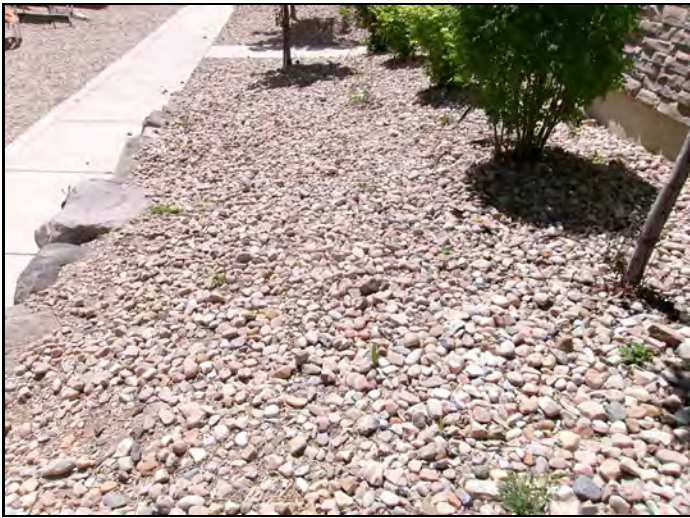
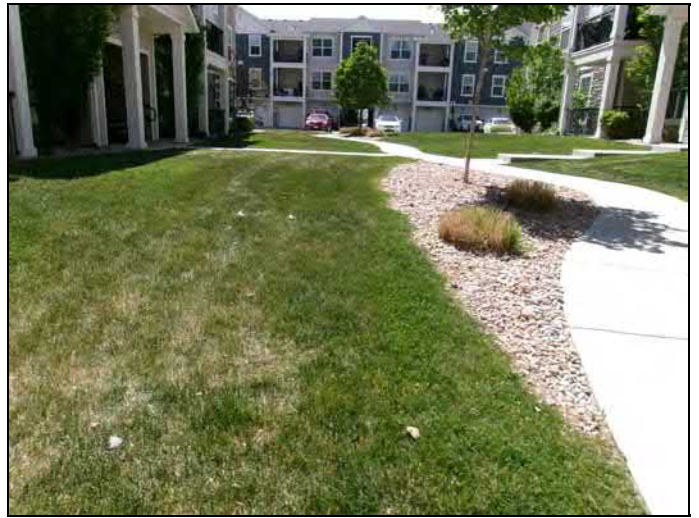
Comp #: 1812 Landscaping & Irrigation System - Renovate

The landscaping and irrigation system appear to be in good condition. We recommend funding for an allowance to renovate this component approximately every 20 years. Remaining life based on current age.

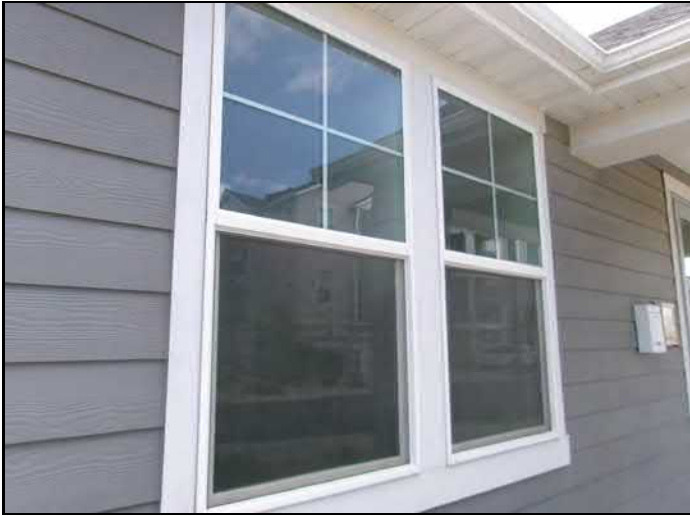
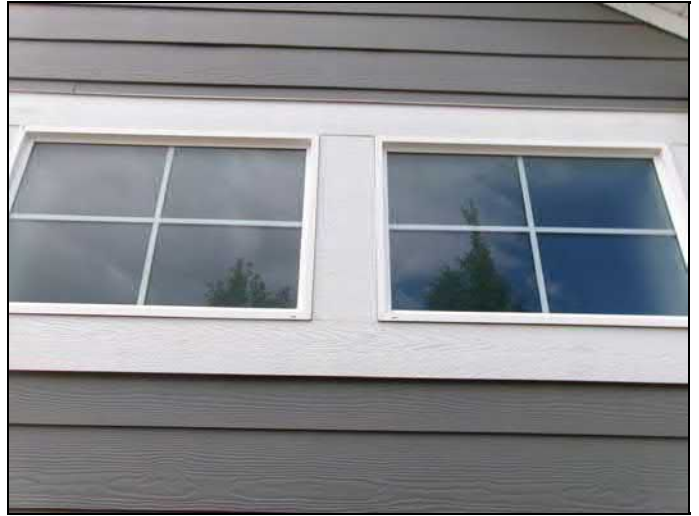
Comp #: 2303 Windows - Replace

The windows appear to be in good condition. We recommend funding to replace this component approximately every 40 - 50 years. Remaining life based on current age.

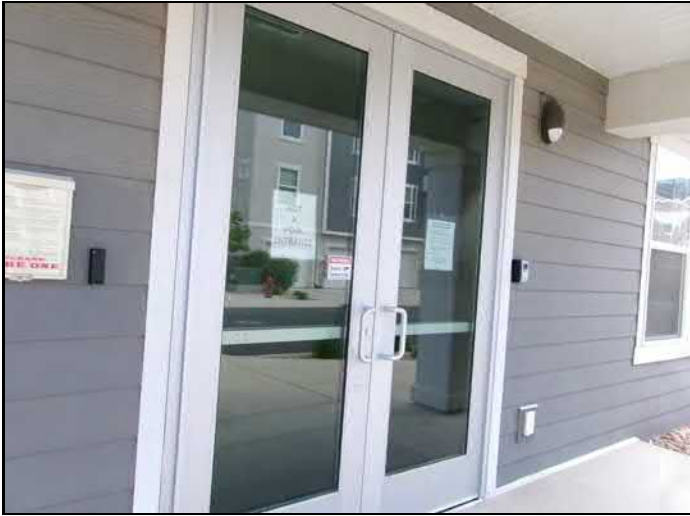
Comp #: 2304 Exterior Doors - Replace

The doors are in good condition. We recommend funding to replace this component approximately every 40 - 50 years. Remaining life based on current age.
